WORKORDER

DESCRIPTION HAMILTON FEDERAL BANK IS CHANGING OVER TO HAMILTON BANK.

SURVEY ALL SIGNS FOR REFACED AND RELAMP

HAMILTON BANK - HAMILTON OFFICE - 5600 Harford Rd - Baltimore, MD

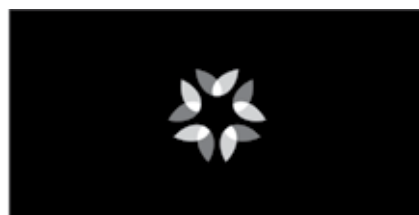
Sign 5

SIGN 5 DOOR VINYL LOCATED ON THE FIRST DOOR FROM THE RIGHT SIDE OF THE BUILDING ("EAGLE" LOGO ONLY)

| Type | - 2nd Surface Vinyl |
| Color | - Gold |
| Logo Height | - 5-1/8"H |
| Logo Width | - 7-5/8"W |
| Door V.O. | - 30"W |

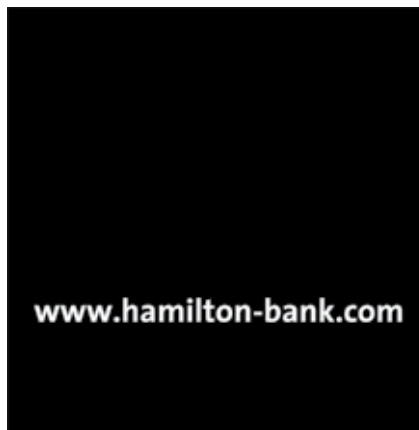
Sign 6

SIGN 6 WINDOW VINYL LOCATED ON THE LARGE LEFT WINDOW TOWARDS THE REAR OF THE BLDG (www.hamiltonfsb.com)

| Type | - 1st Surface Vinyl |
| Color | - White |
| Letter Height | - 7" UC/5" LC |

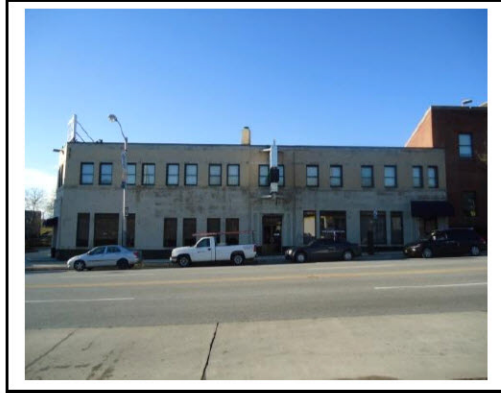
FRONT ELEVATION

SIGN 1 ILLUMINATED PROJECTING SIGN CABINET LOCATED @ THE TOP NEAR THE CENTER OF THE BLDG (Hamilton Federal Bank)

Cut Size	- 50-1/2"H x 74"W
V.O.	- 47-1/4"H x 70-1/2"W
Retainers	- 1-3/4"
Cabinet Color	- Mil Finish Stainless Steel
Lamps	- Unable To Get To Lamps
Ballasts	- Unable To Get To Ballast
Face Type	- White Plastic - Flat
Copy Type	- Blue Plastic Letters Glued To Background

SIGN 2 ILLUMINATED PROJECTING SIGN CABINET LOCATED @ THE TOP NEAR THE CENTER OF THE BLDG (ATM & Star Logo)

Cut Size	- 22-3/8"H x 82-1/4"W
V.O.	- 21"H x 80-7/8"W
Retainers	- 3/4"
Cabinet Color	- Mil Finish Stainless Steel
Lamps	- Unable To Get To Lamps
Ballasts	- Unable To Get To Ballast
Face Type	- White Plastic - Flat
Copy Type	- 1st Surface Vinyl

SIGN 3 LIMESTONE CARVING IN BLOCK ABOVE 2ND DOOR FROM RIGHT OF BLDG - BELOW SIGN 1 (HAMILTON FEDERAL SAVINGS & LOAN ASSOCIATION 1951)

Type	- Carved Text/Eagles In Limestone
OA Width	- Of Entire Block - 42-1/2"H x 10' 7-3/4"W
OA Width	- Between Eagles - 76-3/4"H x 10' 7-3/4"W
Letter Height	- 5"H

Notes	- If Brand Name were to be covered, it should at least be considered to do so in a way that would allow the two eagles to remain they are.
-------	--------------------------------------------------------------------------------------------------------------------------------------------

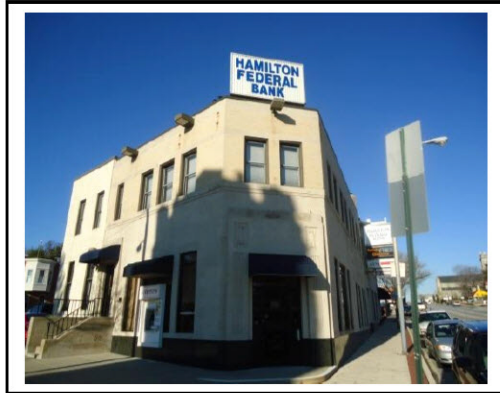
CORNER ENTRANCE

SIGN 7 LIMESTONE CARVING IN BLOCK ABOVE 2ND DOOR FROM RIGHT OF BLDG - BELOW SIGN 1 (HAMILTON FEDERAL SAVINGS & LOAN ASSOCIATION 1951)

| Type | - Carved Text/Eagles In Limestone |
| OA Width | - Of Entire Block - 42-1/2"H x 10' 7-3/4"W |

SIGN 8 DOOR VINYL LOCATED ON THE MAIN ENTRANCE DOOR ON THE LEFT CORNER OF THE BLDG (HAMILTON FEDERAL BANK W/EAGLE LOGO)

| Type | - 2nd Surface Vinyl |
| Color | - Gold |
| OA Copy Height | - 4"H x 26-1/2"W |

| Notes | - If Brand Name were to be covered, it should at least be considered to do so in a way that would allow the two eagles to remain they are. |

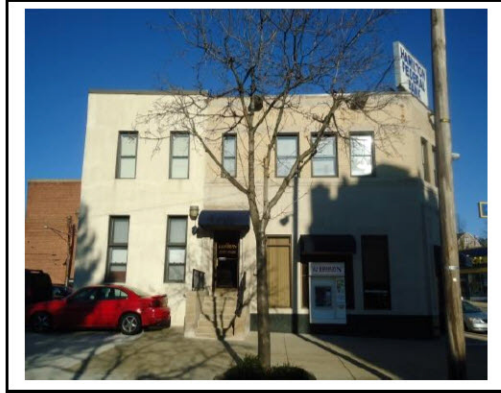
EVERGREEN AVE ELEV (SIDE)

SIGN 9 WINDOW VINYL LOCATED ON THE WINDOW TO THE LEFT OF THE ATM (www.hamiltonfsb.com)

Type	- 1st Surface Vinyl
Color	- White
Letter Height	- 3"H & 2-1/8"H
Copy Width	- 30-1/8"W
Window V.O.	- 33-5/8"W

SIGN 10 DOOR VINYL LOCATED ON THE MAIN ENTRANCE DOOR ON THE LEFT CORNER OF THE BLDG (HAMILTON FEDERAL BANK W/EAGLE LOGO) (MORTGAGE <> EQUITY LOAN (ACCOUNTING DEPARTMENTS)

Type	- 2nd Surface Vinyl
Color	- Gold
Hamilton Hgt	- 9-3/8"H (Does Not Include Eagle)
Hamilton Wdt	- 26-1/2"W
Line 2 Dim	- 1-1/4"H x 22-1/2"W
Line 3 Dim	- 1-1/4"H x 24-1/2"W
Door V.O.	- 31"W

SIGN 11 ATM SURROUND FACE LOCATED IN THE ATM ON THE LEFT SIDE NEAR THE CENTER OF THE BLDG

Cut Size	- 14"H x 46-1/2"W
V.O.	- 14"H x 46-1/2"W
Retainer	- None
Lamps	- Unknown
Ballast	- Unknown
Notes	- Face should have a 1/4" Radius on all 4 corners
	- Face has no retainers, and is held in place with (4) visible Tek Screws

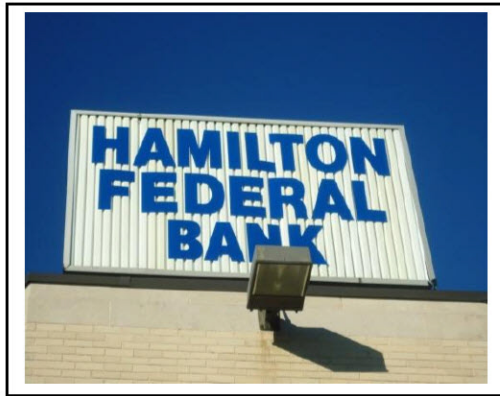
ROOFTOP PYLON (SINGLE FACE)

SIGN 12 ROOFTOP PYLON SIGN LOCATED AT THE ABOVE THE MAIN ENTRANCE ON THE LEFT CORNER

Cut Size	- 72"H x 10' 0-1/8"W
V.O.	- 68"H x 9' 10-1/8"W
Retainer	- 2-1/8"
Trim Color	- Mil Finish Stainless Steel
Lamps	- 6 - F120T12HO - (Actual Length = 117-5/16")
Ballast	- 2
Hanger	- None
Face Type	- White Corrugated Plastic
Face Depth	- 3/4" - See Rubbing
Corrugation	- Runs Vertical
Copy Type	- Glued On Blue Plastic Letters
